# Chester Fire Station

## Existing Facilities Conditions Report: *Needs Assessment Analysis*

April 9, 2024

Acre Architects  
S2 Architecture  
Dillon Consulting  
CBCL

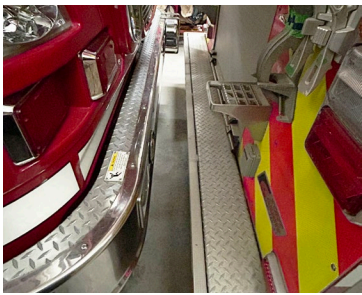
The apparatus bay does not meet the current nor future requirements of the fire department. There is insufficient height, length and space within the apparatus bay for operational and safety clearances, to work on or wash apparatus, or to house the rescue boat and other equipment. The bay doors are not an adequate width or height to accommodate modern apparatus. There is a lack of separated PPE storage space and no isolated decontamination facilities to support the long-term safety of the volunteers. There is insufficient hose drying infrastructure and storage space, which results in inefficiencies and the degradation of hoses over time.

Bay 4 Firetruck Clearance

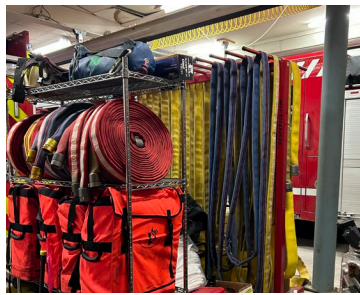
Bay 3 Hose Drying/Storage

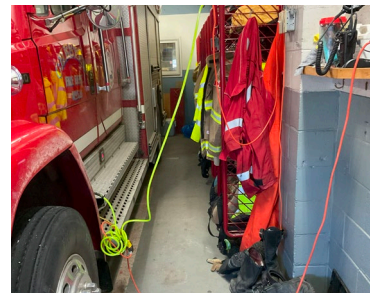
PPE Storage/Radio in Bay 1

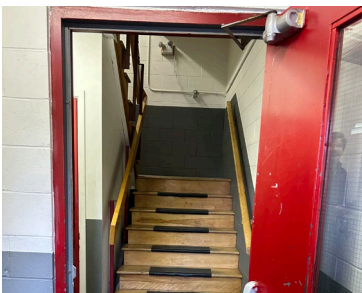
The existing building does not provide a barrier-free entrance, circulation space or washroom facilities and is therefore not suitable for the public. There are no designated barrier-free parking spaces or a barrier-free path of travel leading to the entrance. The only access to the meeting room on the second floor is via stairs.

Stair at Entry

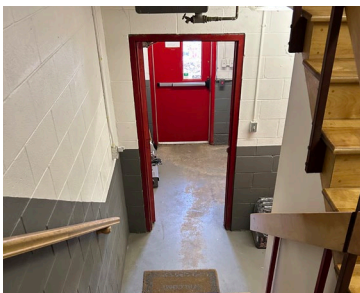
Stair looking at Entry

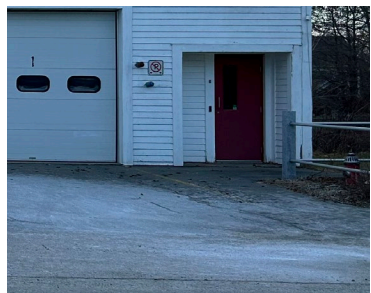
Main Entrance from Exterior

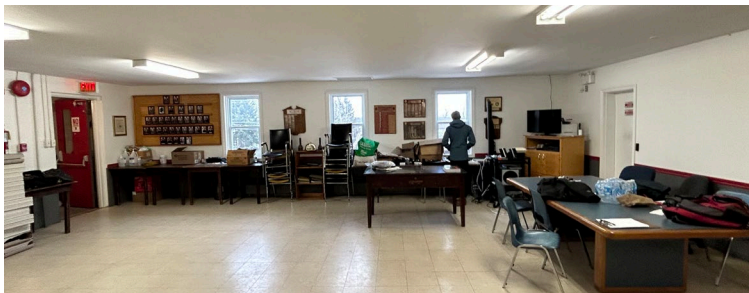
The current meeting room has insufficient space and height to accommodate training, department meetings and social functions. It was noted that poor acoustics result in auditory challenges during larger meetings and events. The only cooling system is one window air conditioning unit, resulting in discomfort during larger gatherings throughout the warmer months. The only access to the meeting room is via stairs, rendering it an inaccessible space.

Meeting Room

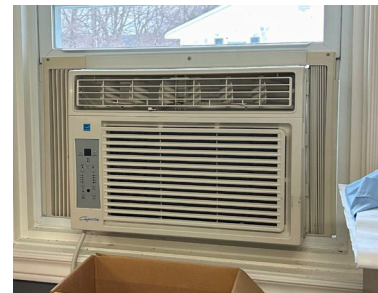
Residential-Style Air Conditioning Unit

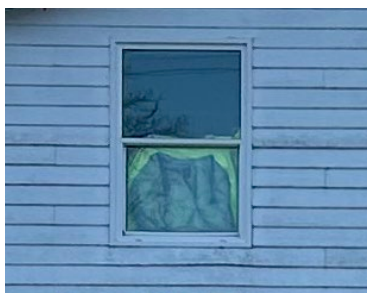
The existing windows appear to be at least 30 years in age with vinyl frames. Due to the height of the sloped roof, there is insufficient wall space to accommodate windows on the south wall, resulting in skylights in these rooms. The skylights are in very poor condition with significant water damage at several locations.

Exterior Window

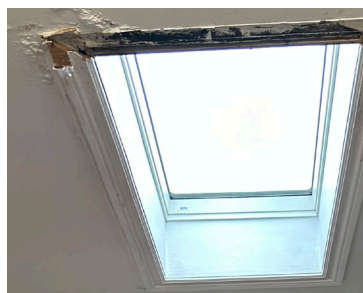
Skylight Water Damage

Several locations on the upper level show water damage, namely around skylights and in and around the kitchen and washroom areas.

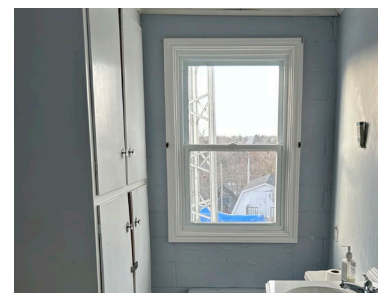
Bathroom Window

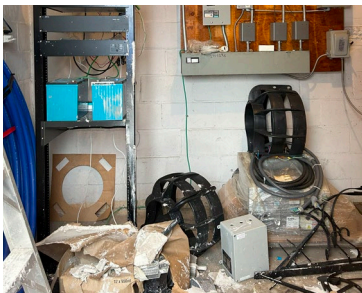
There is significant water damage in the mechanical and electrical room that requires repairs. There is also insufficient operational clearances in front of the mechanical and electrical equipment. As there is no IT / communications room, the IT equipment is housed in the secure chief's office which leads to access challenges when servicing is required.

Fallen Ceiling in Mechanical Room

There is no basement present in the building. The mechanical and electrical room which houses the boiler and other equipment is located at the rear of the building. There is currently water damage in the room due to a burst pipe.

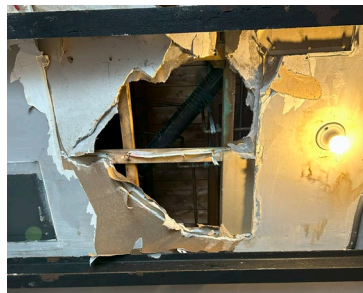
Ceiling Hole in Mechanical Room

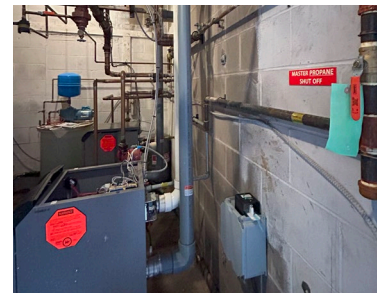
Mechanical Room

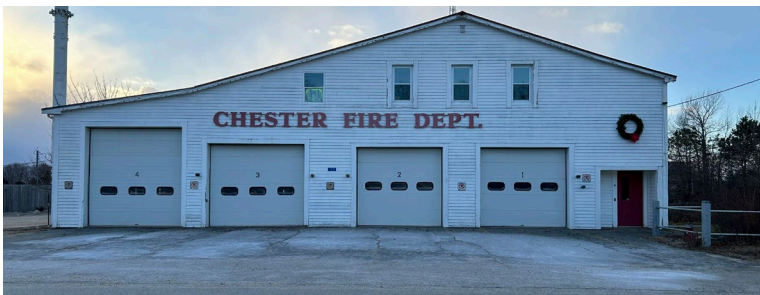
The service apron is gently sloped from the building towards Central Street. The asphalt is in poor condition with significant rutting and cracking. The fire department requires approximately 20m-25m of hard-surfaced staging area outside the bay doors to fit firefighting apparatus, which the current site can not accommodate.

Service Apron to Bays

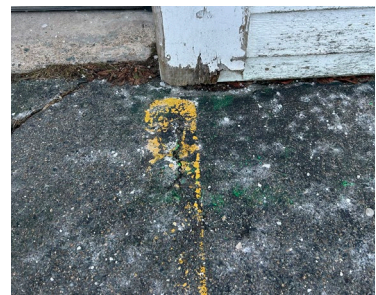
Asphalt at Building

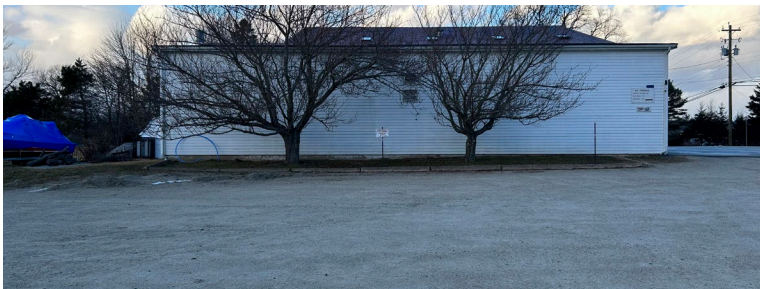
The on-site portion of the existing gravel parking lot is approximately 20m x 25m, providing unmarked parking for approximately 20 vehicles. The gravel parking lot is in fair condition requiring minor regrading and maintenance. Department events require parking for approximately 50-75 vehicles which the current site can not accommodate.

In addition to the parking being unmarked, there are no dedicated barrier-free parking spaces or a barrier free path of travel leading to the entrance.

Firefighter Gravel Parking

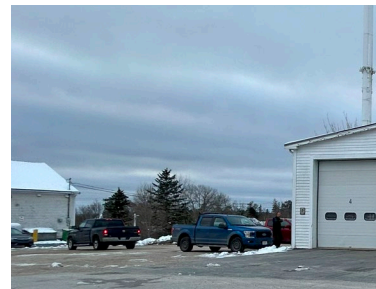
Firefighter Gravel Parking from Street

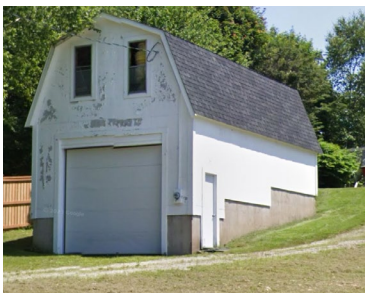
Existing storage includes a shed and exterior equipment storage. Additional covered exterior storage for equipment is desirable.

Back Shed

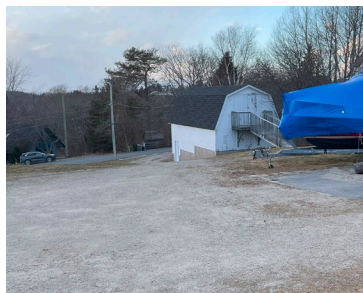
Back Gravel Pad and Shed

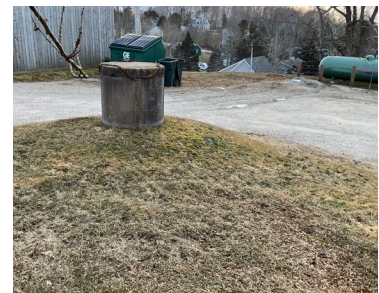
Existing exterior training area is limited. Exterior training areas are generally larger than what the current site can accommodate and can include hard surfaced areas for training such as hose training, vehicle extraction, stair tower, and etc.

Back Gravel Pad

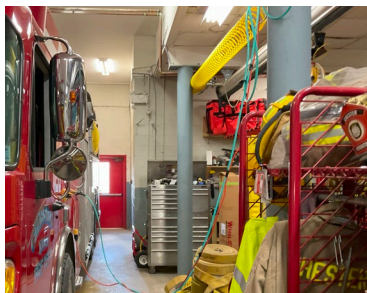
Structural System Change in Bay 4

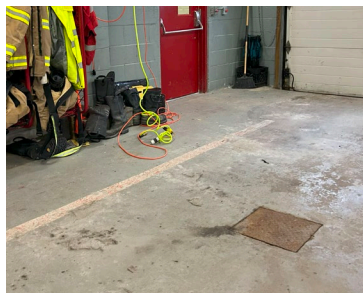
The interior concrete slab on grade in the main garage areas is in fair condition. However, drainage is poor with insufficient number of drains and inadequate sloping to the existing drains

Slab in Bay 1

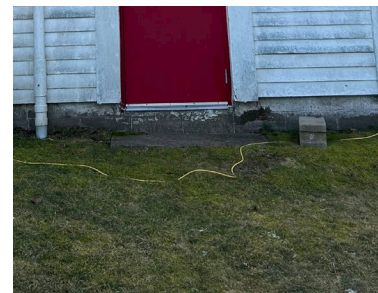
The original building foundation appears to be concrete masonry construction whereas the building additions appear to be conventional concrete foundations. However, the majority of the perimeter foundation wall is not exposed above grade and was covered with snow at the time of the review, so was not able to be reviewed in detail.

Foundation at Side Door

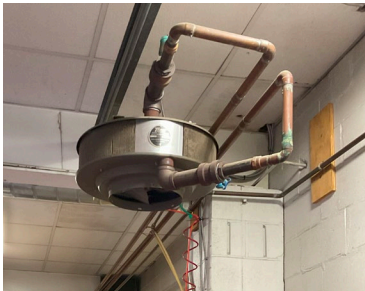
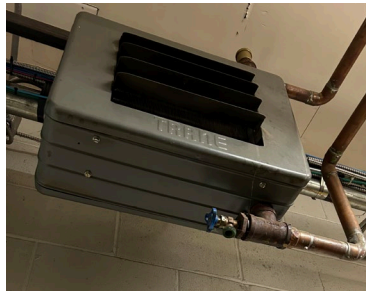
Unit Heater

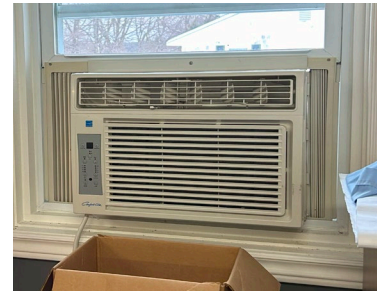
Heating is provided by two hot water propane gas-fired boilers. While the exact installation date of the boilers is unknown, they appear to be recent and in good condition. Accessories serving the boilers (valves, air vent, strainers, steel piping, etc.) display external corrosion. Un-insulated copper piping distributes the heating water throughout the building and would require upgrades to meet current energy code requirements. In general, hot water unit heaters are installed in the garage and technical spaces, and hot water baseboard are used in the office spaces. The building's only AC equipment is a window unit located in the multi-purpose/meeting room.

Window Air Conditioning Unit

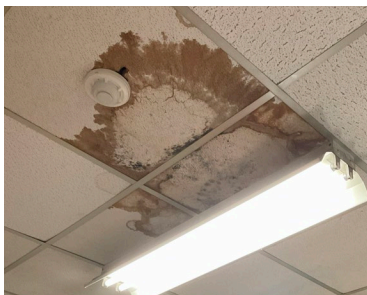
Bathroom Water Damage

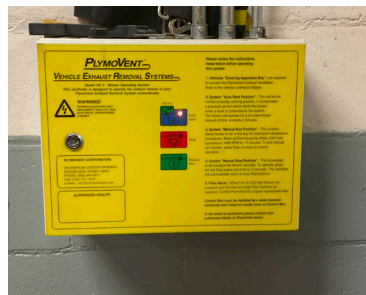
The apparatus bay requires upgrades to include general ventilation meeting ASHRAE 62.1 standards, an air exhaust system, and a CO/NOx detection system. The administration areas also require general ventilation to comply with ASHRAE 62.1. Exhaust fans (or HRVs) would be required for washrooms, kitchens, and janitor closets to facilitate air extraction.

Vehicle Exhaust Ventilation System

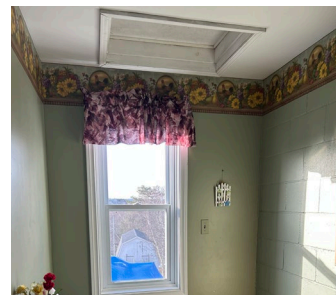
Bathroom Without Ventilation
