# Chester Fire Station

## Existing Facilities Conditions Report: *Needs Assessment Analysis*

April 9, 2024

Acre Architects  
S2 Architecture  
Dillon Consulting  
CBCL

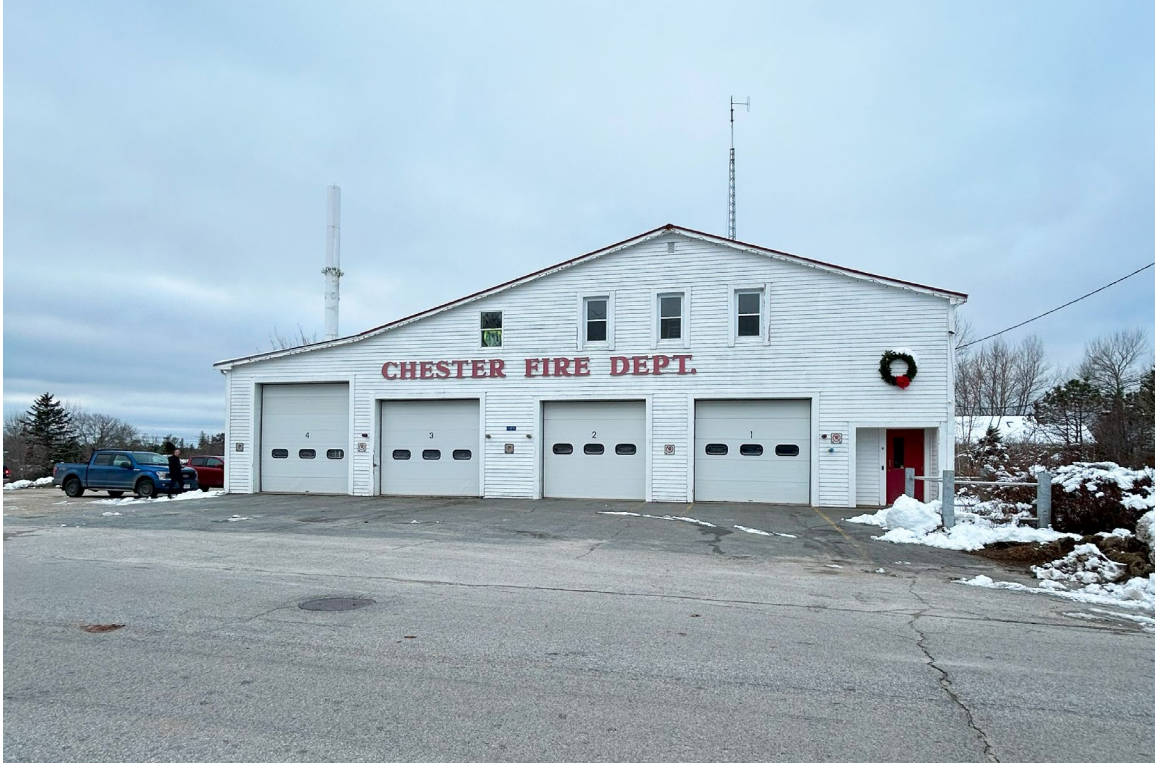
Existing Fire Station

The existing building was originally completed in 1936 and has undergone several major renovations/additions, including a reconstruction completed in 1960 due to a fire that took place in 1959. As no original building drawings are available and the extent of the previous renovations are unclear, this will present a challenge to complete a full assessment of the building condition to determine if upgrades will be structurally feasible, and the extent that would be required to meet current building code and post disaster requirements.

The fire station has several non-conforming conditions, including the contemporary requirement to serve as a post-disaster building. This requirement largely impacts the structural system, which is not limited to roof, columns, cross-bracing, foundations and footings, and can also impact fixed-in-place components and equipment. Due to the structural implications, this can be a cost-prohibitive retrofit for typical buildings. However, for fire stations which must maintain operations during renovations, such work also requires major solutions to spatial and system impacts during construction.

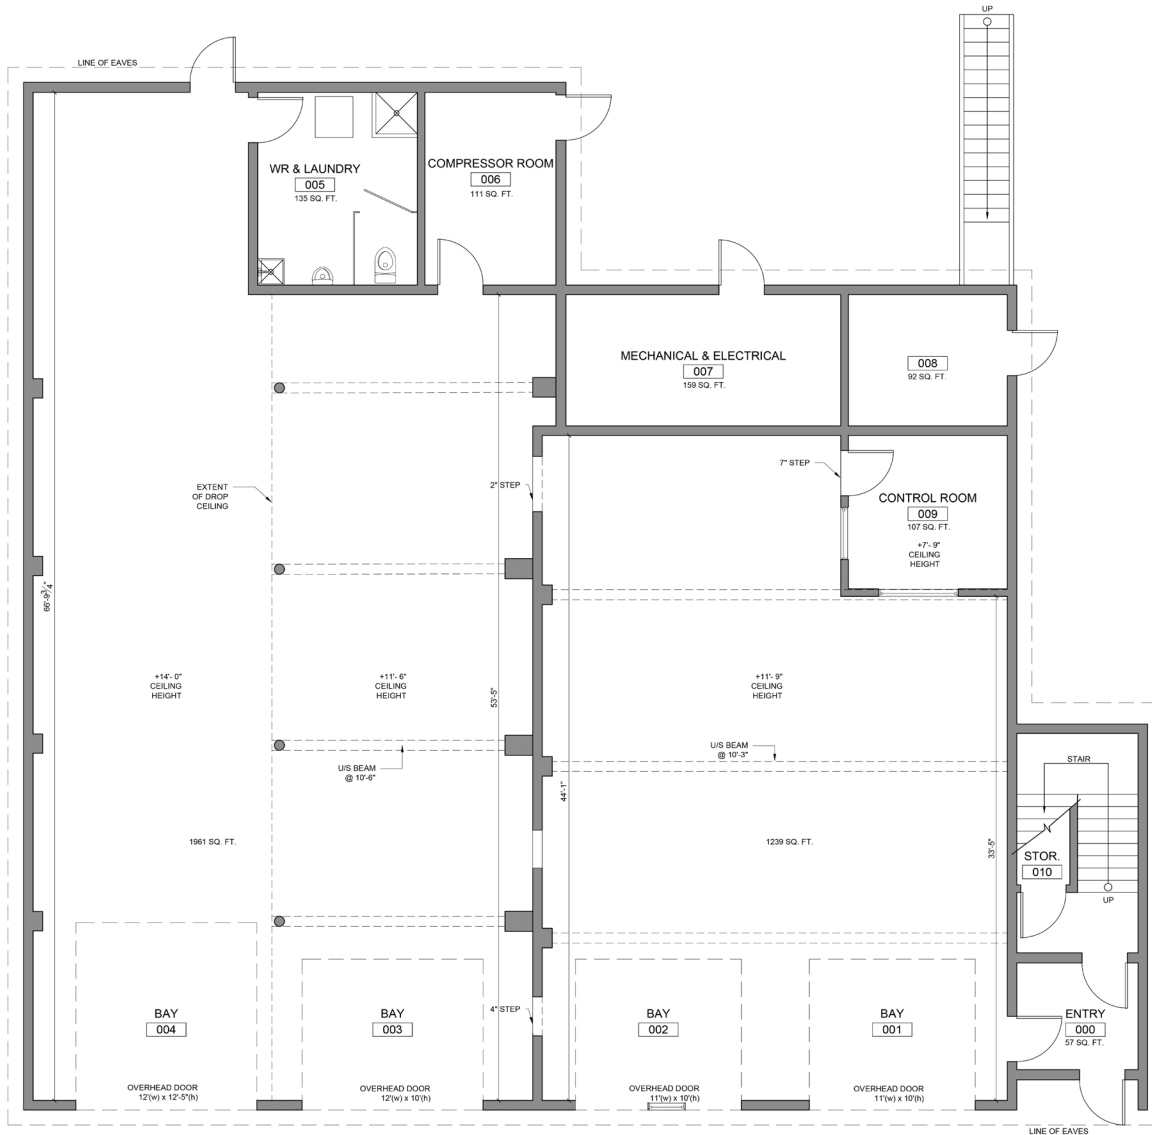
Existing First Floor Plan

There is insufficient space and support functions in the existing fire station to meet the demands of the fire department, resulting in a lack of comfort for the volunteer firefighters, improper storage, inefficient operations and, ultimately, slower response times.

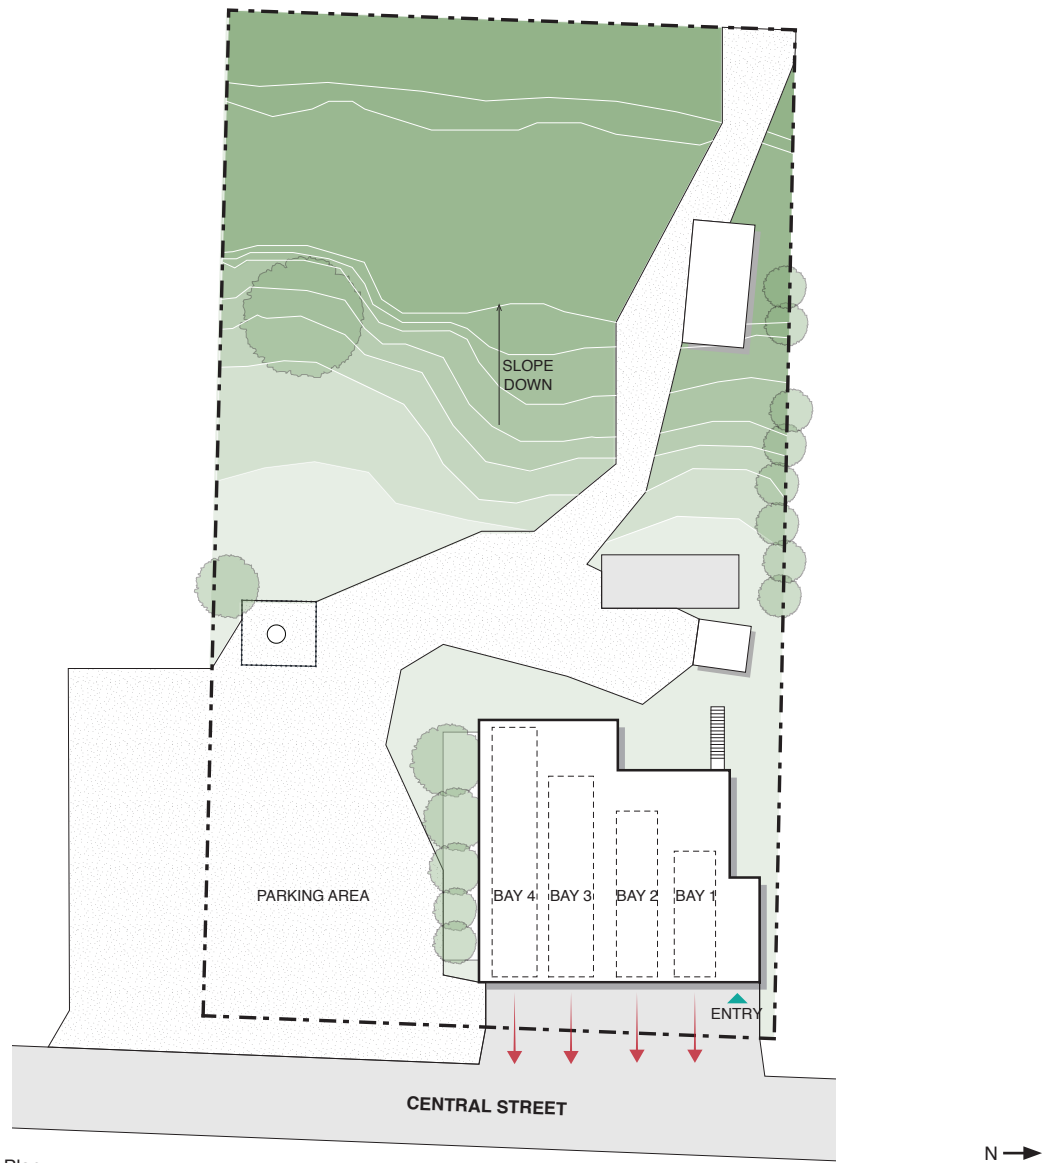
Existing Site Plan

The current site is approximately 0.380ha. The eastern half is generally level, at or near the elevation of Central Street. The building is located in the north-east corner of the site and is connected to Central Street by an asphalt service apron along the entire building frontage. There is a gravel parking area to the south of the building, and a small gravel access route with various accessory buildings to the west (rear) of the building. The remainder of the west site area slopes steeply down to Prince Street.

The service apron is gently sloped from the building towards Central Street. The asphalt is in poor condition with significant rutting and cracking. The fire department requires approximately 20m-25m of hard-surfaced staging area outside the bay doors to fit firefighting apparatus, which the current site can not accommodate.

The on-site portion of the existing gravel parking lot is approximately 20m x 25m, providing unmarked parking for approximately 20 vehicles. The gravel parking lot is in fair condition requiring minor regrading and maintenance. Department events require parking for approximately 50-75 vehicles which the current site can not accommodate.
